Protective Coating and Repair System for Potable Water Contact

Belzona 5812DW is an NSF (ANSI 61) certified coating for metallic and non-metallic surfaces in contact with aqueous solutions.

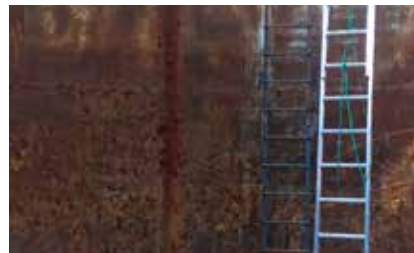
Before and After:
